Some notes about Mason Town Hall insulation.

Thermal images of the Mason Town Hall were taken March 27, 2018. Night time temperatures had been in the low teens, under clear sky and low winds. Sunrise was due at at 6:38 AM. Thermostat inside showed 53°F

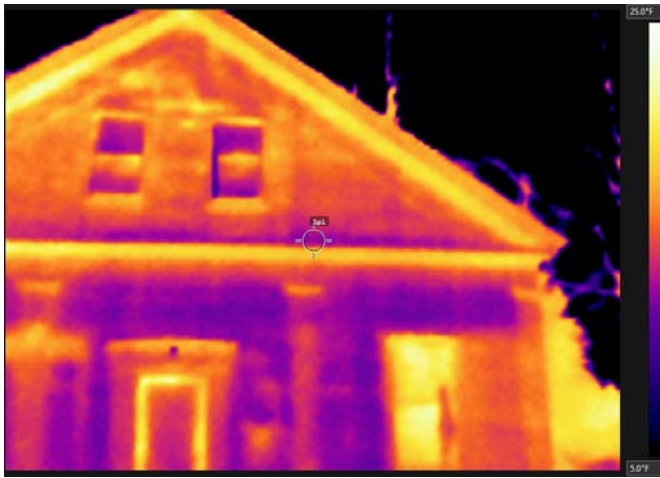
Front

For almost all of the lower floor, the studs are warmer (leaking more heat) than the wall sections between - indicating that those walls are insulated. An exception is seen in the lower right side of the front view - which corresponds to the location of the stairs from the main room to the second floor. Lack of insulation here is further confirmed by thermograms taken inside.

Note in the side view the warmer strips just under the roof soffits; these are matched with a similar strip of warmth (poor insulation) at the same height in the front view. These likely represent the solid wood top plates which support the rafters.

Note that all windows are significantly warmer - these single-pane windows represent a major path of heat loss.

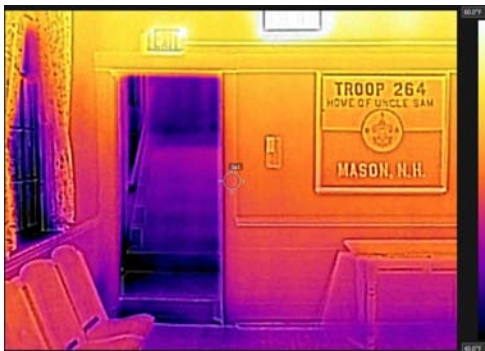
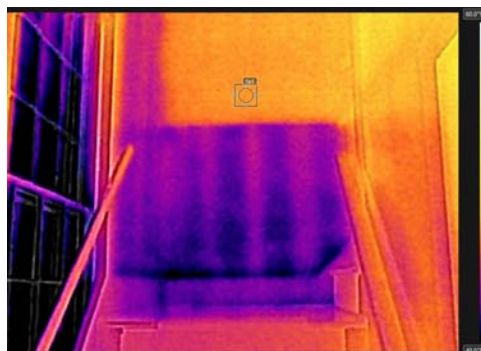
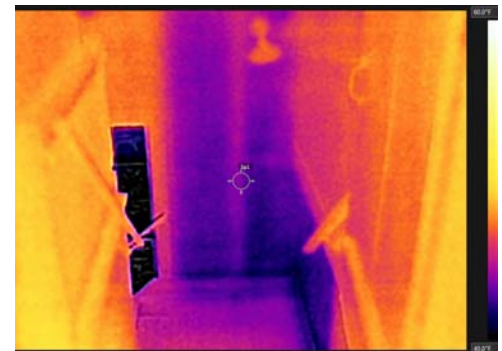
The stairs to the 2nd floor exit from the main room's rear left corner (as seen in inside images).

This area is noticeably cooler - in part due to the exit door and window the the left of the stairs, but also due to the lack of outer wall insulation in this corner location - see the detail images of landing from below and above. This stairwell should be a major path for warm air rising to the 2nd floor, so its coolness seems especially significant.

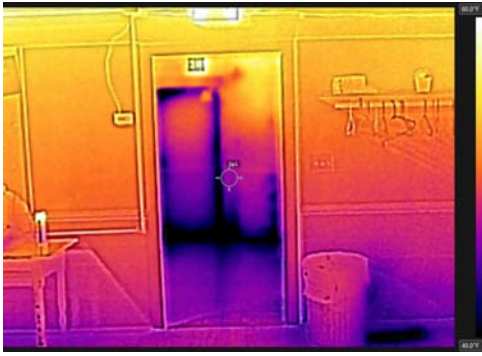
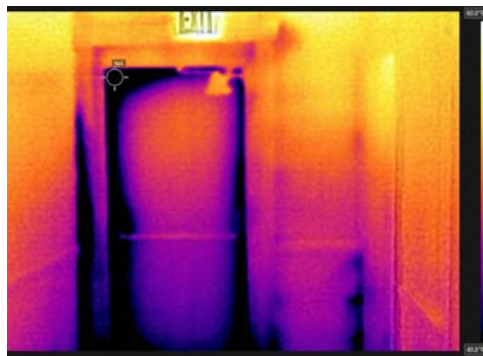
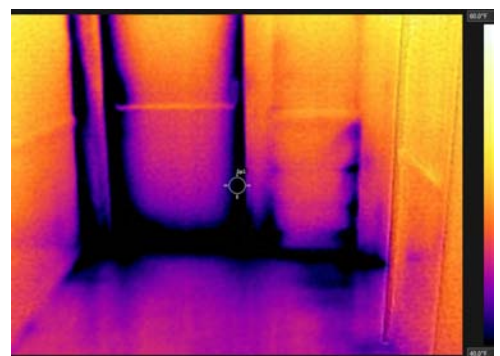
The corridor to the front door is another source of heat loss. The fit and weatherstripping of the outside door shows visible openings through which heated air escapes.

The upper left corner of the door (see center image) has a visible gap to the outside and a temperature of 27.5°F. The lower portion of the door and adjacent floor read low 30's down to 29°F.

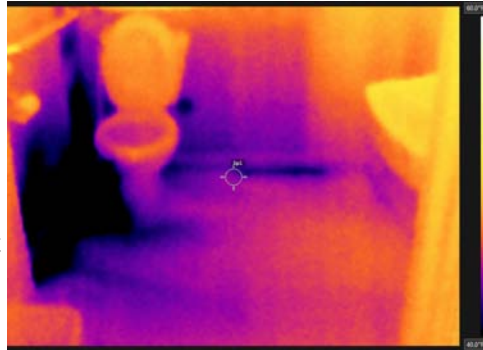
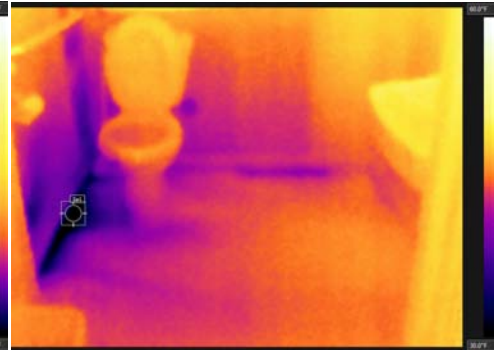
The first (left-hand) image shows the 40-60°F scale used in most images.

The right-hand image's scale's low temperature has been shifted down to 30°F to reveal more detail in the coldest areas. The lowest temperatures seen there are below 27°F.

There may be a risk of freezing in the adjacent toilet or in its plumbing below.

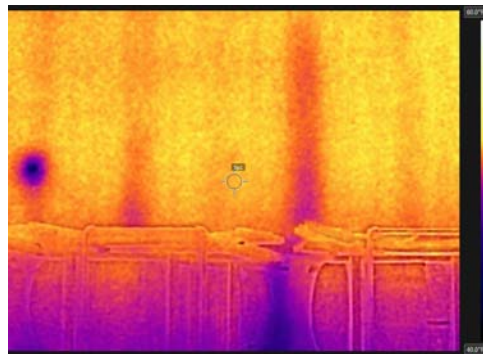
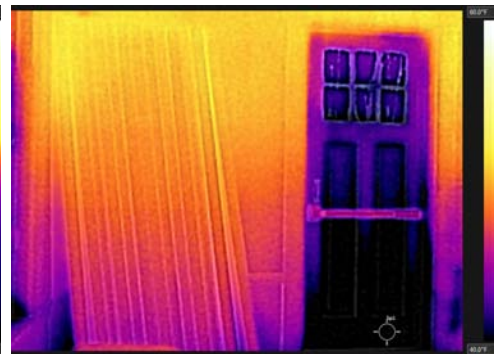
Moving to the front of the room - the stage - we again see evidence of insulated walls (colder over the studs than between them) and a cold door.

In the left-hand picture at the far left there is a curious circular heat leak - perhaps a large bolt anchoring something onto the outside of the wall?

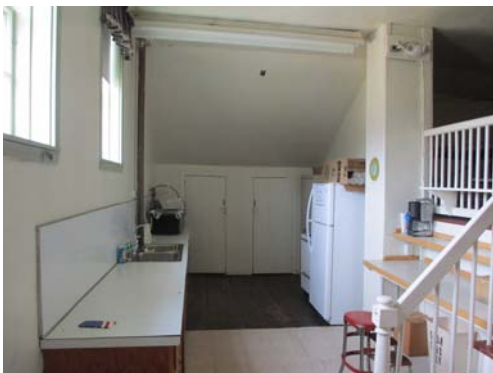
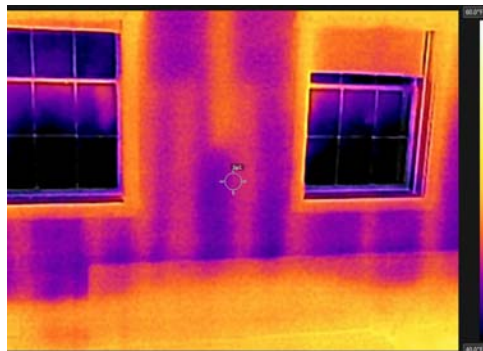
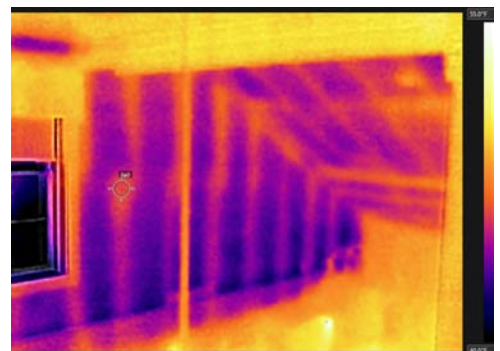
Going up the steps we enter the 2nd floor via the kitchen area. Neither the gable end walls nor the overhead ceiling sloping with the roof are insulated.

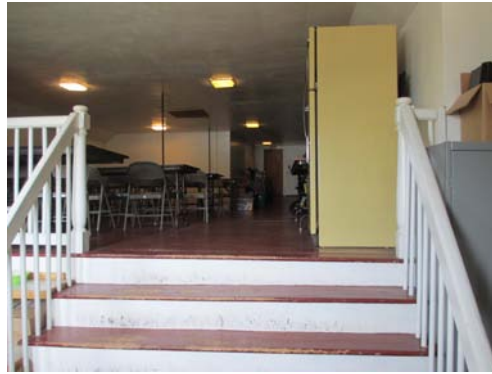
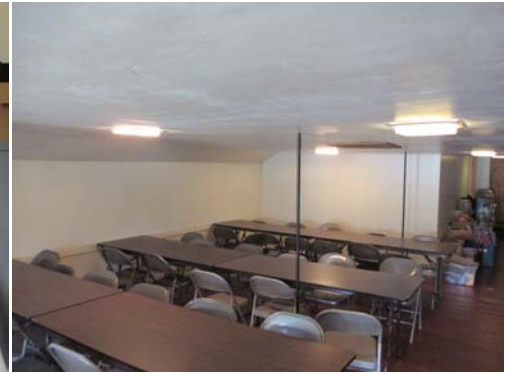
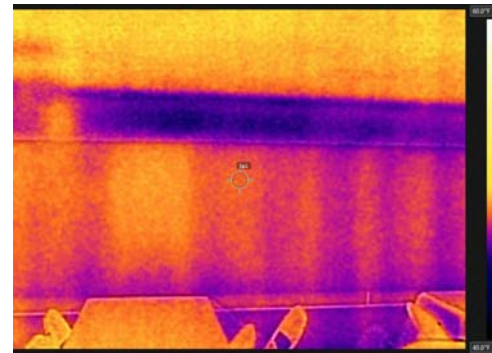
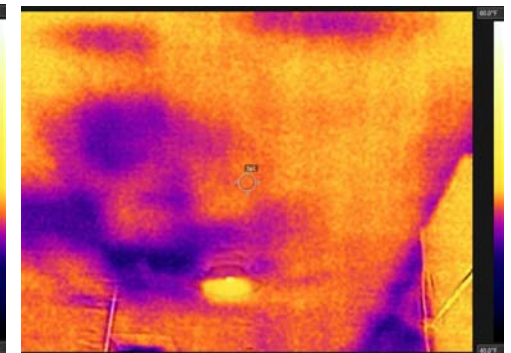
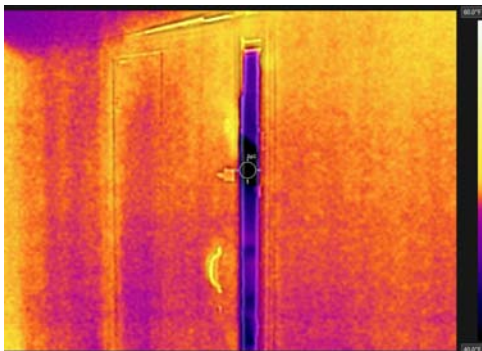
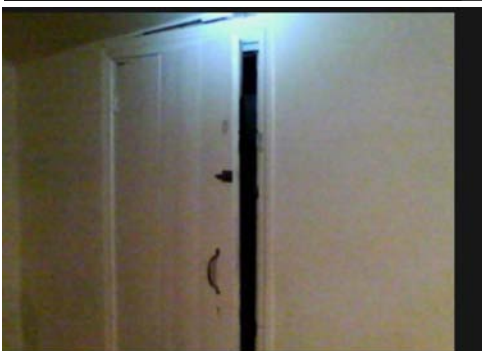
The side walls appear to be uninsulated (warmer over studs than between).

The hipped section between the vertical walls and the ceiling appears to be attached directly to the rafters without any insulation, and is noticeably colder.

The ceiling shows some odd thermal blotches. These might be due to displaced insulation (if there is any), condensation droplets, or ??.

Settling of the building has warped many of the door frames to the extent that the doors can no longer close. This allows copious air flow from the boxed-in dining area into the sub-roof area which is uninsulated and well ventilated by visible gaps in the soffits.
